CARBON FIBER SUBFRAME DEVELOPEMNT – CORROSION MITIGATION STRATEGIES AND TEST RESULTS

Xiaoming Chen, Kyle Anderson, Niamh Hosking and David A. Wagner
Ford Motor Company
Nikhil Bolar
Magna, Cosma International

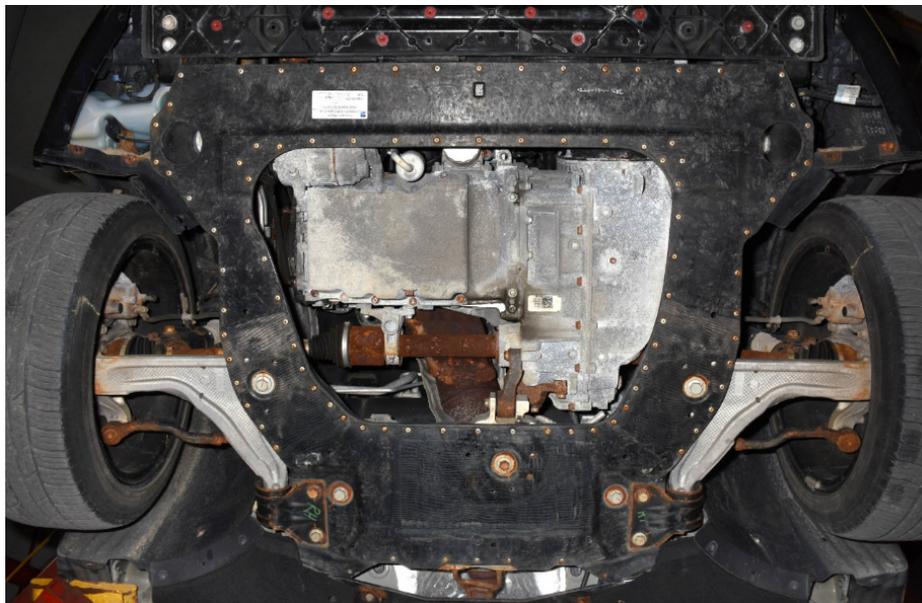
Visual inspection of the underbody was conducted throughout the vehicle corrosion test and photos of the subframe after 4, 8 and 12 weeks of testing are shown in Figures 12-14. Red rust was observed on the rivets and bolts but no loss of function occurred.

Figure 12: CFRP subframe – post 4 week corrosion test

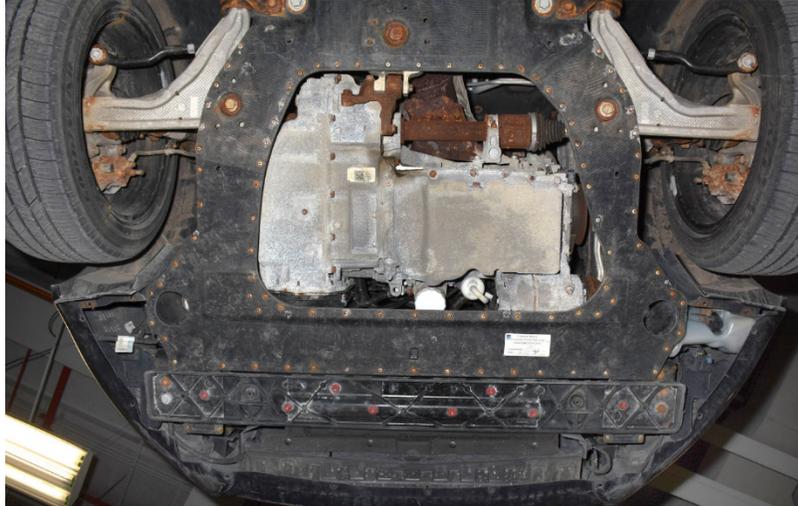
Figure 13: CFRP subframe – post 8 week corrosion test

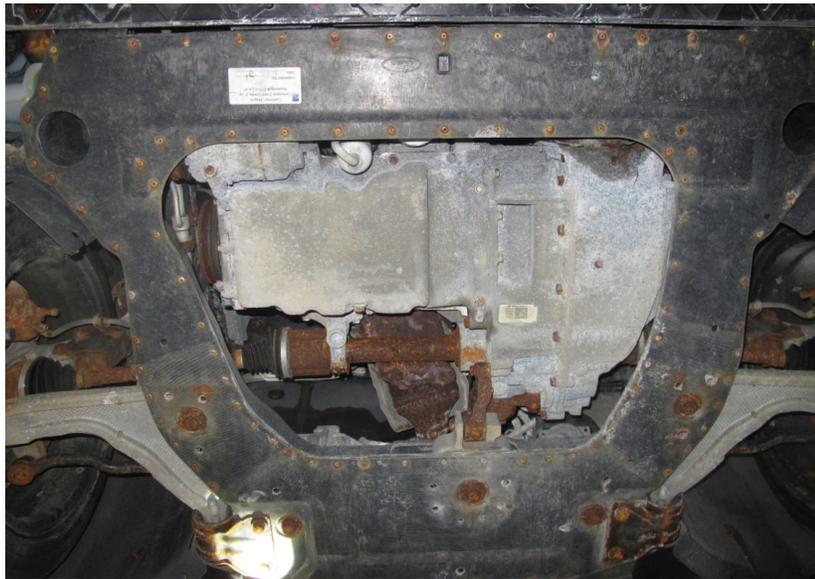
Figure 14: CFRP subframe – post 12 week corrosion test

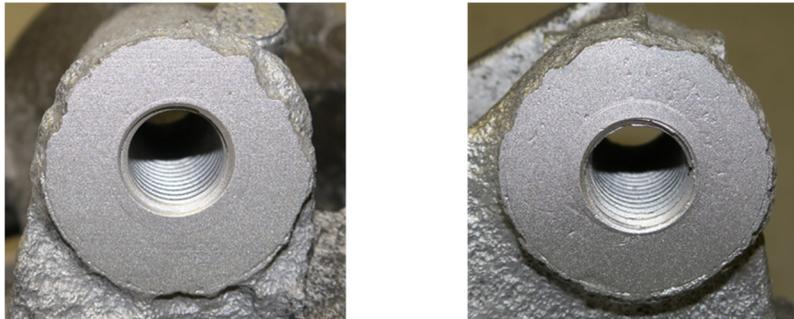
The aluminum steering gear was mounted to the CFRP subframe through stainless steel compression limiters (sleeves), as shown in Figure 16. The sleeves themselves did not exhibit corrosion; however, the mating surfaces on the steering gears experienced considerable metal loss at the interface (Figure 17). These observations confirm that stainless steel is compatible with CFRP but it may induce galvanic corrosion on an adjoining less noble metal, such as aluminum.

Figure 17: metal loss observed on steering gear mounting surfaces

The aluminum steering gear mounting surfaces were not compatible with the stainless steel inserts. Significant galvanic corrosion of the aluminum mating surfaces to the stainless steel inserts was observed and quantified.

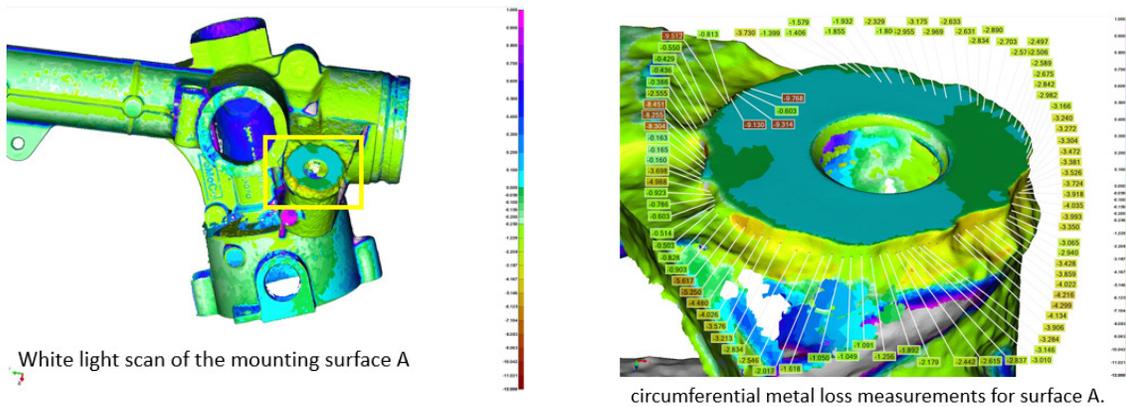
The steering gears were optically scanned so the amount of metal loss could be measured when compared to the nominal CAD model. An example of this analysis is shown in Figure 18 for mounting surface A. The summary of steering gear material loss for the component tests is shown in Table 2. The vehicle test data are not included as the steering gear was replaced during test for an unrelated test.

Figure 18: steering gear mounting surface metal loss measurement

Component ID	A-1		B-1		A-2		B-2	
	A	B	A	B	A	B	A	B
Average Metal Loss (mm)	2.88	1.89	3.02	0.97	3.20	1.47	3.28	1.42
Std. Dev. (mm)	2.27	1.34	2.16	0.47	2.13	0.90	2.67	1.01

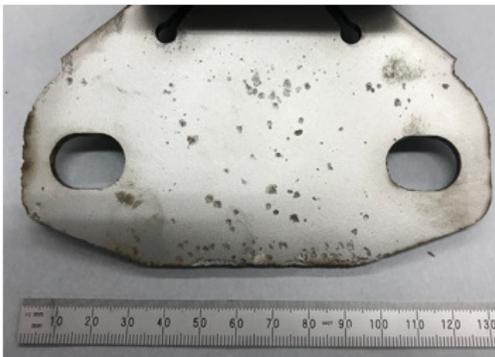
The lower control arm brackets are e-coated and directly joined to the subframe. The mounting surfaces of the tested lower control arm brackets were glass bead blasted to remove the e-coat and corrosion product. Significant pitting of the underlying steel substrate was revealed, see Figure 19. A point micrometer was used to determine the depth of the pitting, and a summary of the pit depth analysis is given in Table 3. The left/right orientation is from a view of the component from the front of the vehicle. A large variation of pit quantity and depth was observed across samples. A pictographic comparison of all samples that were analyzed is shown on Figure 20.

LCA bracket surface that interfaces with the top of the subframe.

Figure 19: control arm bracket pitting

The steel lower control arm brackets exhibited pitting on the surfaces in contact with the carbon fiber. The e-coat paint was not sufficient to avoid corrosion on the steel brackets for this design.

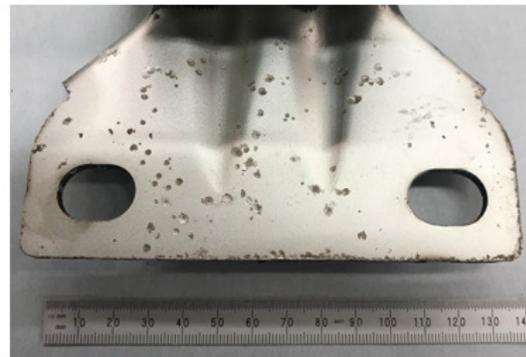
LCA bracket surface that interfaces with the bottom of the subframe.

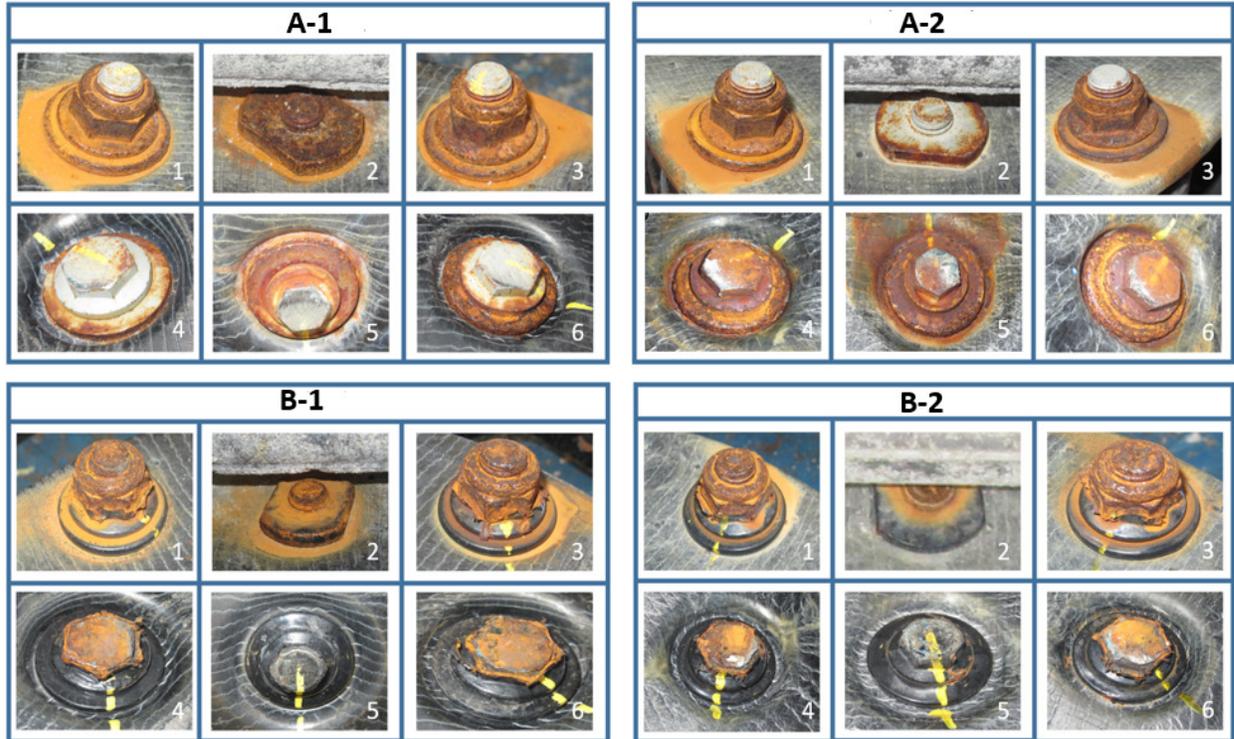
Figure 22: fasteners after 12 week laboratory component cyclic corrosion test

Inspection of these fasteners indicated that the nylon 11 coating adhesion to the bolt/nut heads deteriorated, allowing the development of red rust, see for example B-1.1 and B-1.3. This deterioration could be due to damage of the coating during assembly and subsequent corrosion exposure. Washers with nylon coating did appear to have enhanced red rust resistance compared to bare washers, see for example B-1.5 compared to A-1.5 and B-2.5 compared to A-2.5.

The Nylon 11 which was applied to the washers, bolt shanks, and fastener flanges on two of the subframes appeared to have provided some degree of corrosion protection, most successfully on the washers.

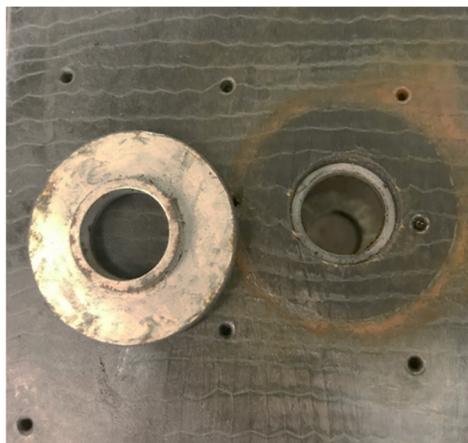
The glass veil incorporated on subframes A-2 and B-2 was tested as a possible isolator for the washers to CFRP surface. Inspection of the washers to CFRP interfaces revealed that even the uncoated washers directly interfacing the CFRP surface did not develop corrosion, see Figure 23. It is speculated that the high clamping load and, in some cases, the recessed location of the washers, occluded moisture, avoiding corrosion. Therefore the effectiveness of the glass veil could not be assessed in this analysis.

Figure 23: interfacing surface of washer to CFRP subframe without glass veil

The effectiveness of the glass veil as an isolator should be investigated in follow-up experiments.
