CARBON FIBER SUBFRAME DEVELOPMENT – FATIGUE AND STRENGTH CAE AND TEST RESULTS

Xiaoming Chen, David A. Wagner and John Uicker
Ford Motor Company
Nikhil Bolar
Magna, Cosma International

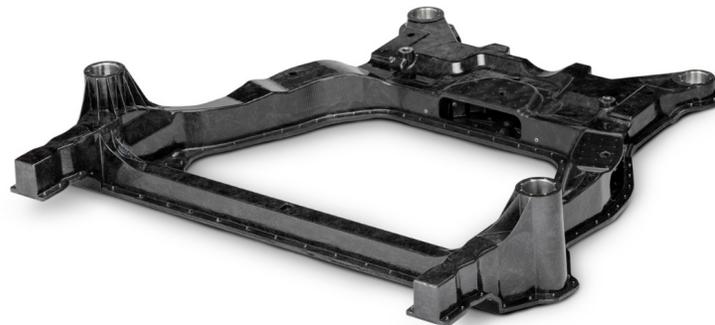
Figure 7: CF composite subframe prototype part

The finished part is shown in Figure 7.

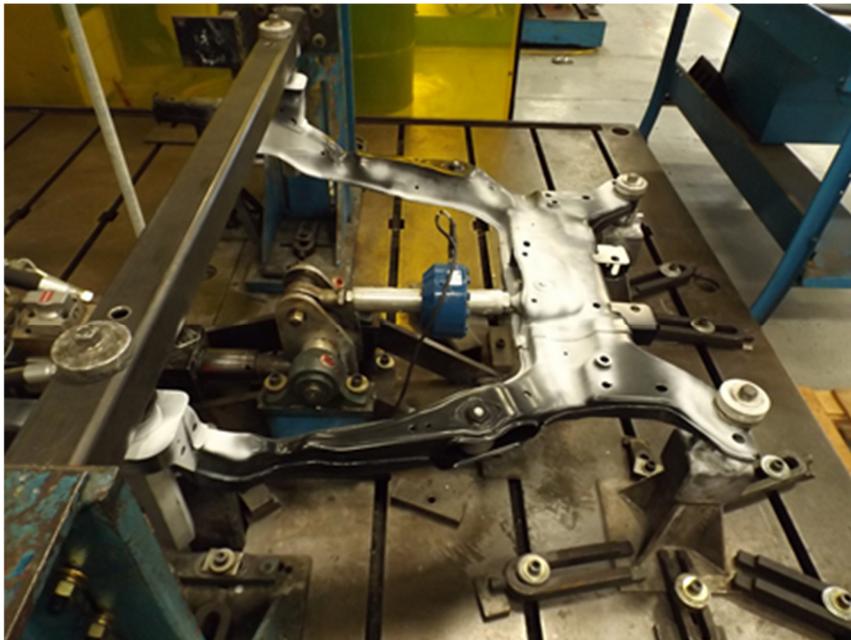
Figure 8: roll restrictor test setup

The subframe was mounted to the bedplate in vehicle position utilizing the body mounts as shown in Figure 8. Horizontal longitudinal block cycle loads were applied 90 degrees to the roll restrictor bushing fastener through a solid loader. The height of the loader was equal to that of the roll restrictor. Lower arm bushings were bolted in the lower arm pockets on all samples.

Horizontal sinusoidal loads of two baseline lives and eight over stress loading blocks were generated from production Fusions' GEDL roll restrictor load events.

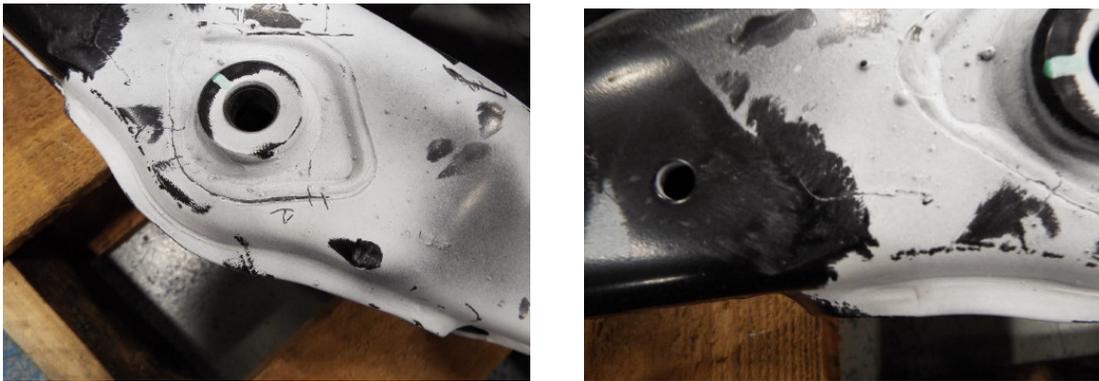
Figure 11: control arm test cracks – steel subframe

The steel subframe was tested through two baseline-loading cycles (two lives). Cracks were detected before completing the second baseline loading cycles (Figure 11)

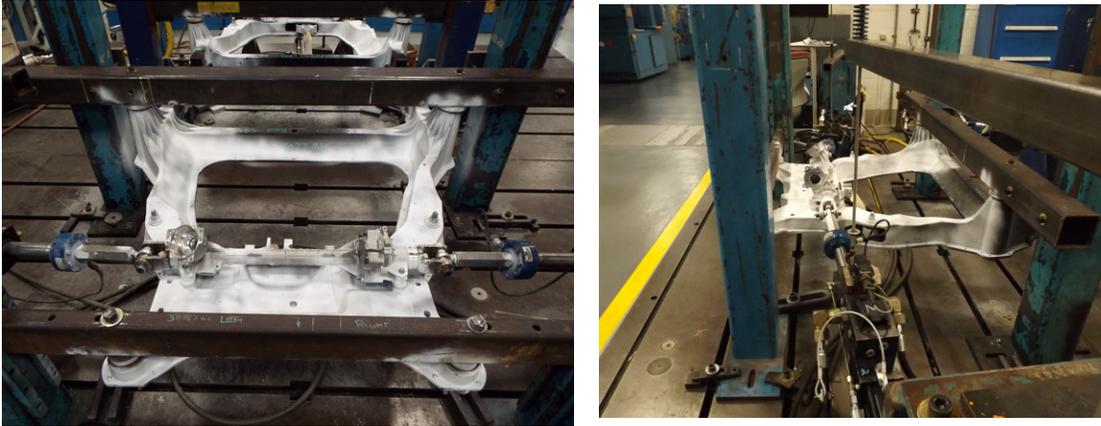
Figure 15: steering gear test setup

The CF subframe was mounted level to the bedplate as shown in Figures 15. The subframe was loaded through a steering gear housing using simulated tie rod ends. The load axis was 6 degrees forward and 6 degrees down at outer tie rod ball joints, 26 mm from the ends of the housing. Lower arm bushings and a roll restrictor were placed in their respective locations and bolted into place.

The two actuators were run 180 degrees out of phase such that when the Left Hand load cell was in tension, the Right Hand load cell was in compression. Block cycle loads were applied with

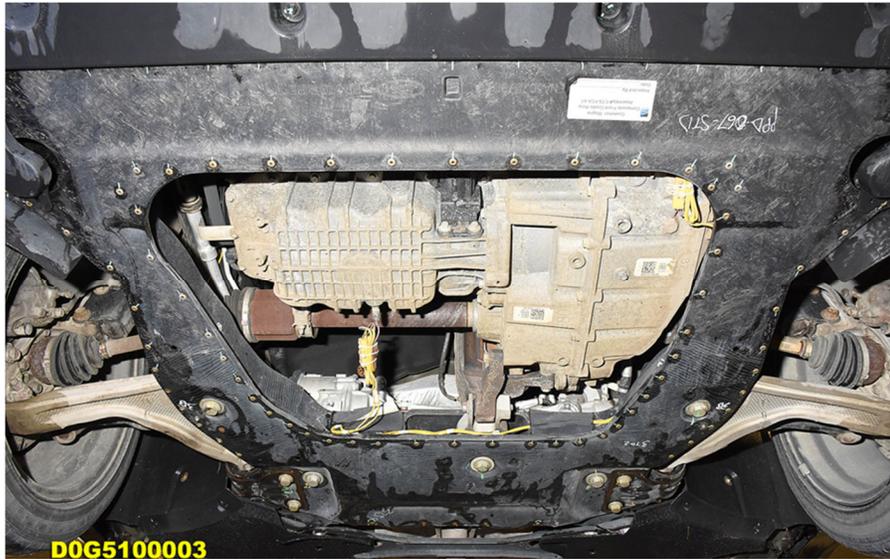
Figure 18: CF subframe – post vehicle durability test

The vehicle completed required test conditions and cycles. No degradation of functions was detected. The post-test inspection, Figure 18, did not find visible movement of fasteners. The Fusion vehicle with a CF composite subframe successfully passed the proving ground durability test.

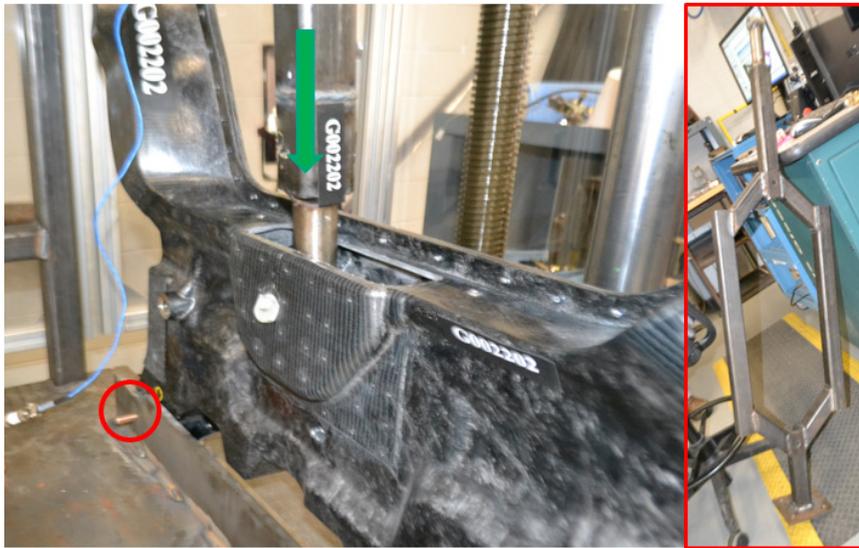
Figure 20: Strength test – roll restrictor loading

For the roll restrictor test, a steel tube was used to represent the roll restrictor bushing. The load was applied in the vehicle's longitudinal direction shown in Figure 20.

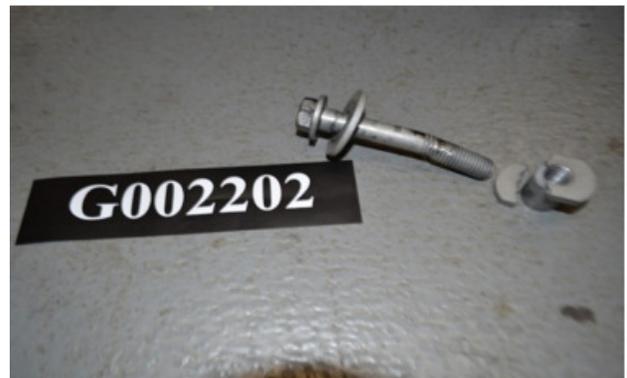
Figure 21: strength test – roll restrictor loading damage

The failure started at the loading location. The bolt hole of the roll restrictor was damaged. The bolt was bent and the nut was broken shown in Figure 21. The force curve is shown in Figure 22. The peak load is about 80 kN.
