FAILURE MORPHOLOGY AND ENERGY ABSORPTION OF PREPREG PLATELET MOLDING COMPOUND TUBES

*Rebecca A. Cutting, Johnathan E. Goodsell, R. Byron Pipes
Composites Manufacturing and Simulation Center, Purdue University, West Lafayette, IN 47906*

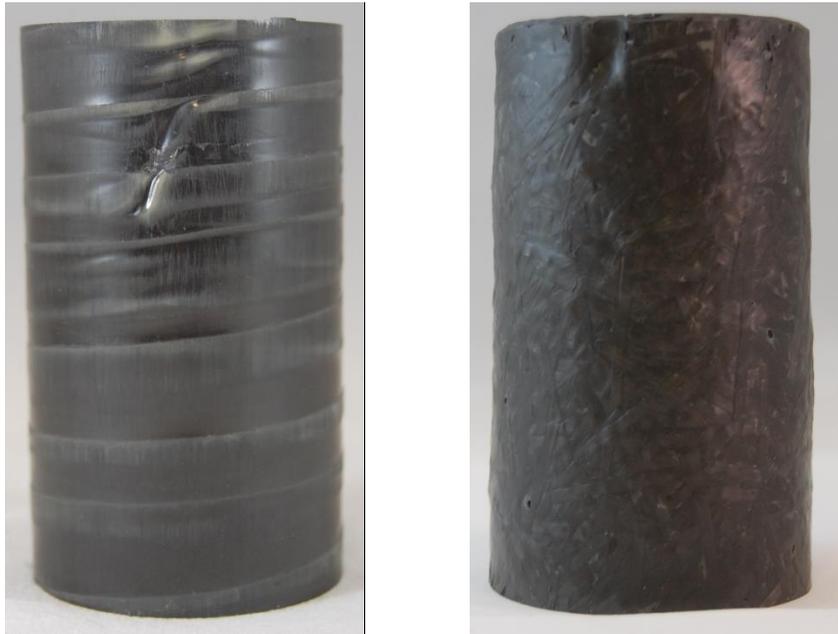
Tubes produced with the heat shrink method had smooth inner surfaces, but significant texture on the exterior surfaces. This is in part because the material was pressurized from the outside in, and the heat shrink tape did not provide a smooth surface for the tube to form to. Figure 5 shows a manufactured unidirectional tube on the left and a PPMC tube on the right. The unidirectional tube has resin rich ridges that were formed due to the overlaps of the heat shrink tape. The PPMC tube has a textured surface with ridges corresponding to individual platelet orientation.

Figure 5: Manufactured tubes from heat shrink method; unidirectional prepreg (left) PPMC (right)

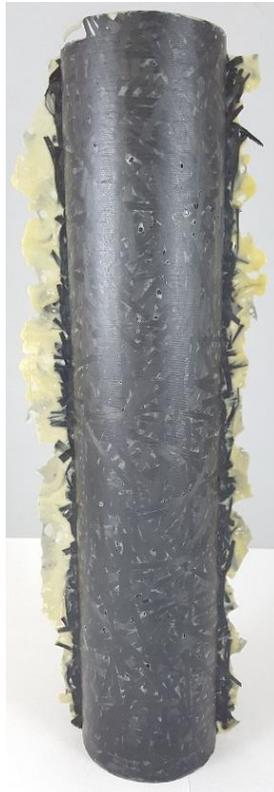
an example of this be seen in Figure 7. The pinched PPMC material does not result in wrinkling of the tube like it would for continuous fiber layups. In this case the tube was pressurized from the inside pushing out resulting in a smooth outer surface that was forced against the mold walls. However, the interior of the tube now has a surface texture similar to the exterior of the heat shrink tubes that depend on platelet overlapping and orientations. The manufactured tubes are cut with a tile saw to produce two 100 mm long test samples. The flash and pinched material are sanded off to create a flush surface.

Figure 7: Demolded tube prior to finishing

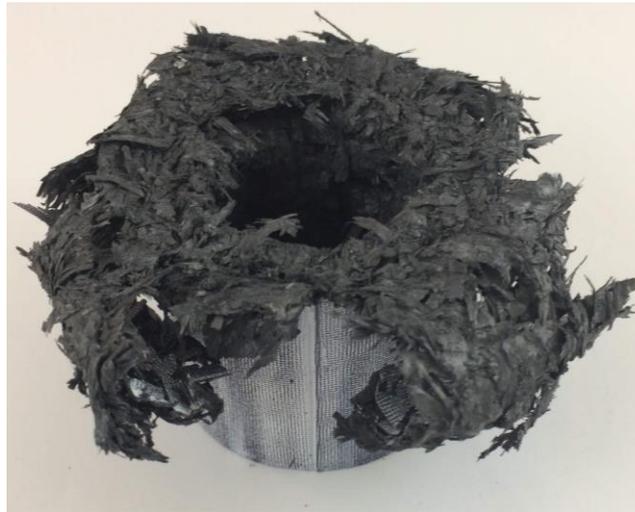
can be seen in Figure 9, and a stitched micrograph of a representative failure site is shown in Figure 10. Delamination occurred between platelets, and large sections of debris curled off from the tube in a splaying fashion. A wedge of debris helped the delamination process extend further down the tube. During the tests, small platelet bundles also broke off the tubes and fell away. The bundles from the PPMC tubes are likely discrete platelets breaking off. Figure 10 specifically shows delamination between platelets as well as the debris and fragments that have broken off of the tube.

Figure 9: Example failure morphology of crushed PPMC tube
