RESTORATION OF STRENGTH IN POLYAMIDE WOVEN GLASS FIBER ORGANOSHEET AFTER IMPACT BY HOT-PRESSING

Mohammad Nazmus Saquib

Composites Modeling and Manufacturing (CMM) Lab

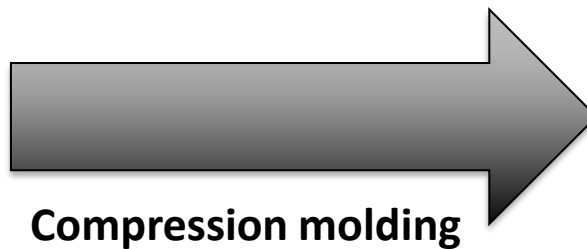
Battery enclosure panel

- Recently under study for state-of-the-art use in electric vehicles (EVs) battery enclosures.
- Its potential as an impact resistant structure is wide due to its high energy absorption capacity, damage tolerance, reparability and design flexibility.

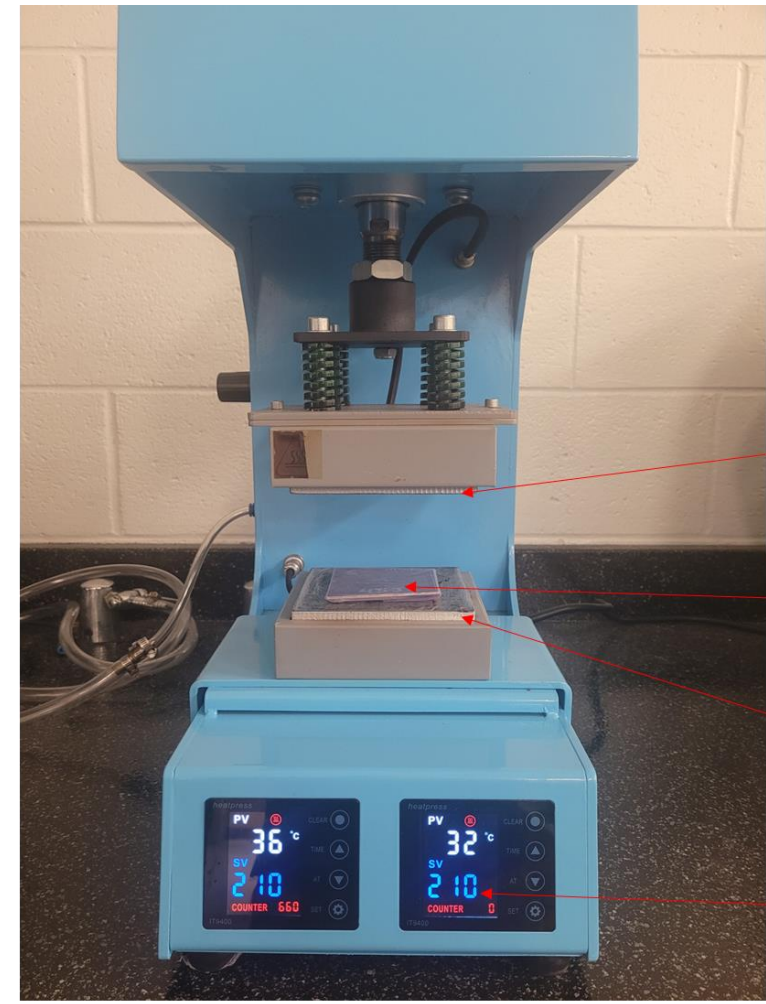
Repair procedure:

- Preheat the sample wrapped in Teflon film at 210°C for 10 minutes.
- Apply a pressure of 1.15 MPa closing the platens for 10 minutes.
- Allowed to air cool the sample.

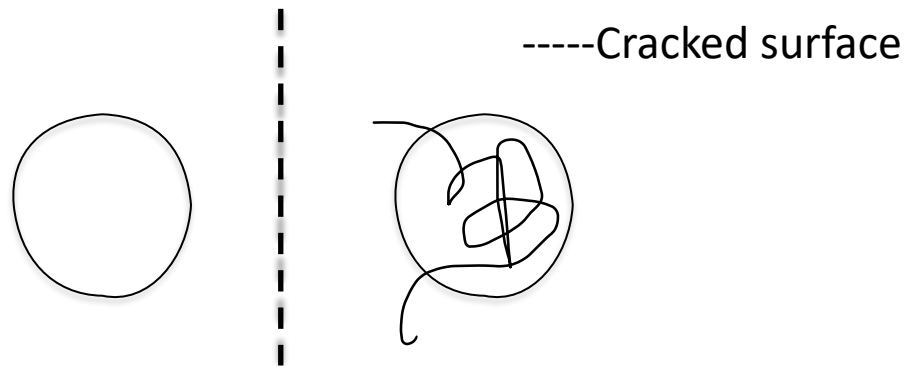
Stage I & II

Stage I : Surface rearrangement

Above T_g , molecule surfaces viscoelastically deform and polymer chain rearranges

Stage II : Cracked surface approach

At this stage, due to intermolecular attraction the molecules initiate surface approach

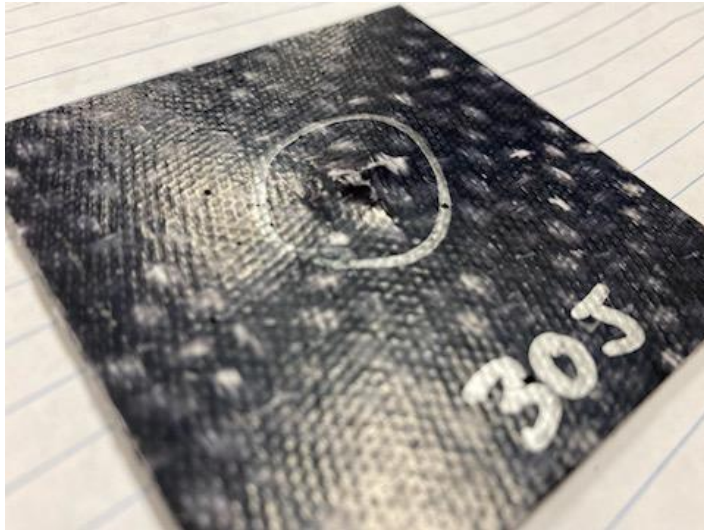
Impacted (30J) organosheet

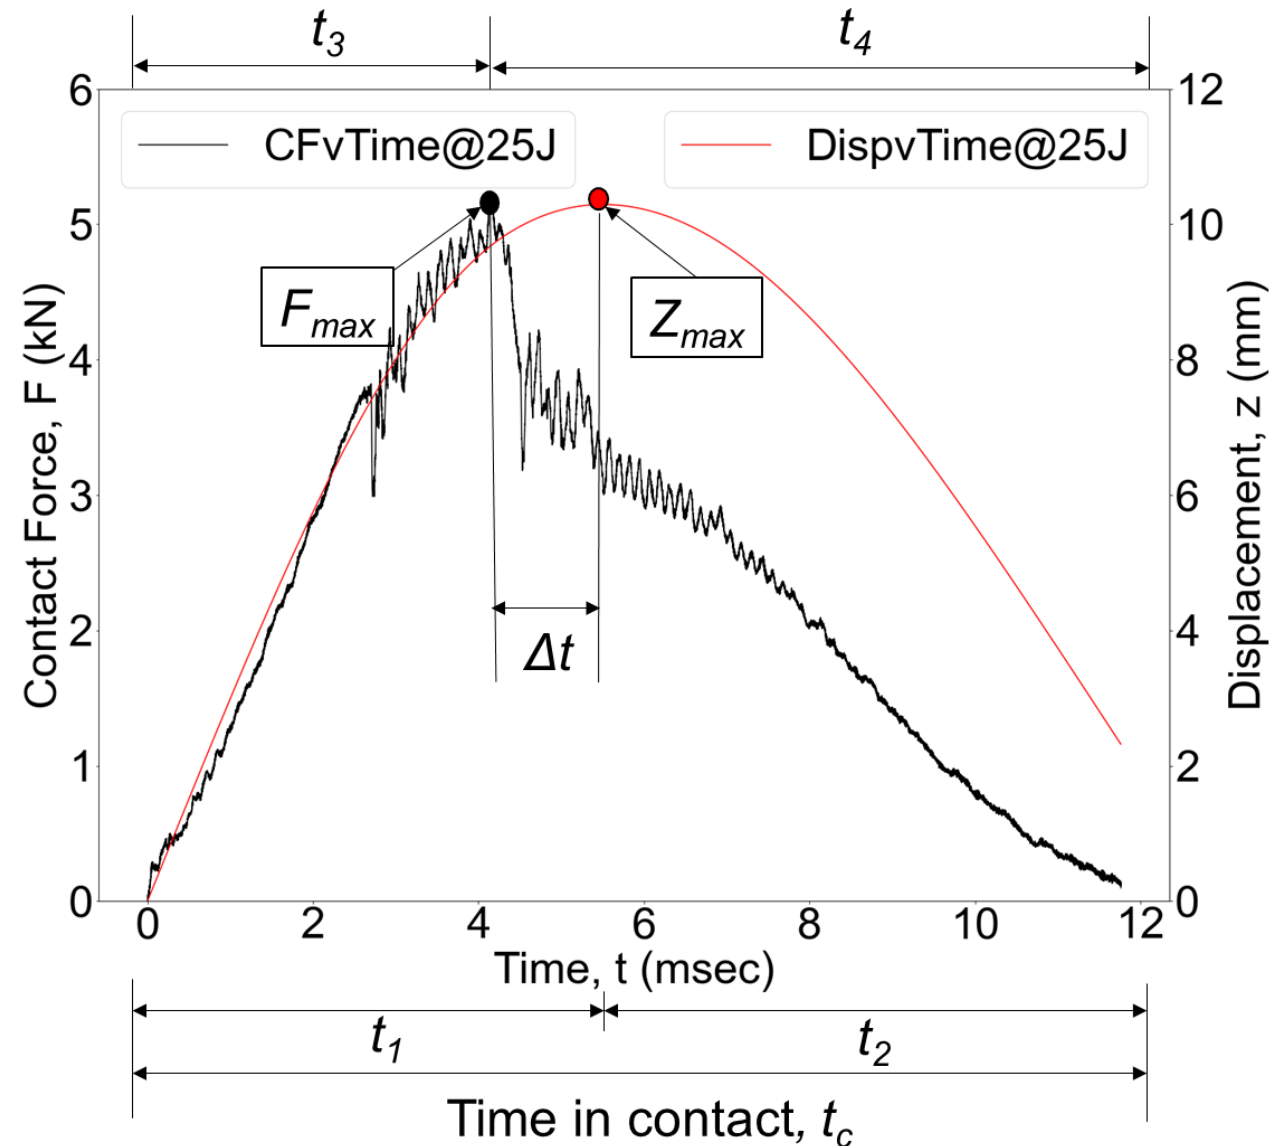
IMPACT BEHAVIOR OVER TIME

- The composite specimen exerts a reaction compressive force (F) on the impactor.
- The force-time ($F(t)$) curve shows a stage of steady force increase until reaching the peak load (F_{max}), with smooth or low-amplitude fluctuations.
- Temporary drops in the $F(t)$ curve indicate the initiation and growth of local damage.
- It takes more time to reach z_{max} compared to F_{max} , resulting in a time delay (Δt) due to the development of damage mechanisms in the material.
- Inelasticity in the impact event leads to variations in the downward travel (t_1) and rebound (t_2) time for the impactor, as well as loading (t_3) and unloading (t_4) time.
- In case of a purely linear-elastic impact (Hertzian solution), $t_1 = t_2 = t_3 = t_4$ and $\Delta t = 0$ is expected, but inelasticity causes variations in these times.

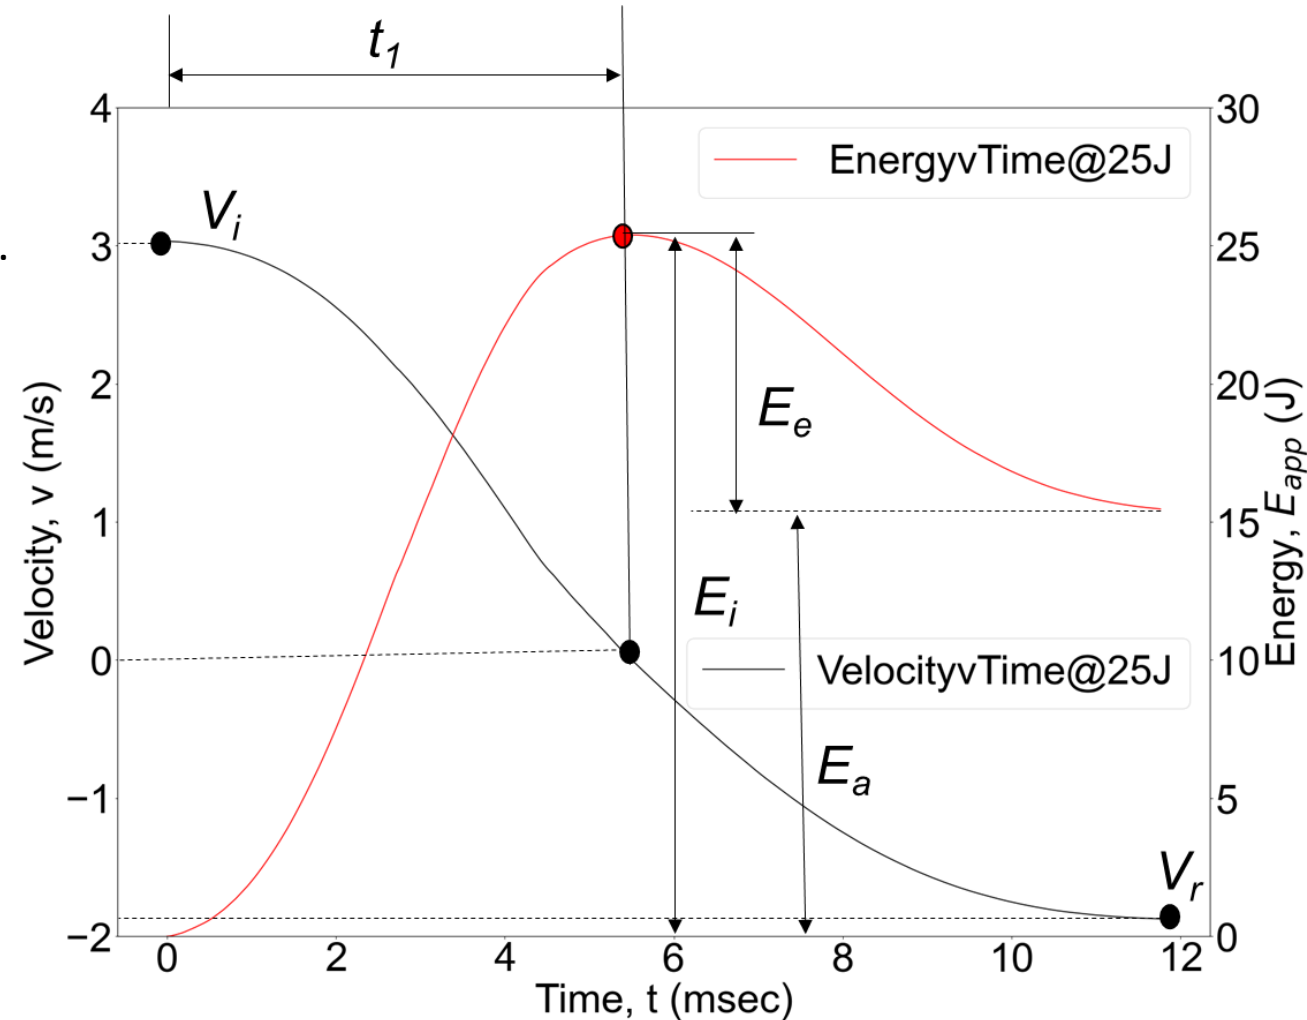
IMPACT BEHAVIOR OVER TIME

- During the impactor's downward travel, its kinetic energy is transferred to the composite specimen, temporarily stored as elastic strain energy, leading to an increasing $E_{app}(t)$ curve.
- Once the local material strength is reached, a portion of the applied energy dissipates through irreversible damage.
- When all the incident kinetic energy (E_i) of the impactor is transferred to the composite specimen, $E_{app}^{max} = E_i$.
- $E_{app}(t)$ gradually decreases as a fraction of the energy is transferred back to the impactor, causing it to bounce back.
- The energy curve eventually reaches a constant value, representing the total energy permanently absorbed (E_a) by the composite specimen.
- The part of E_i responsible for the impactor bouncing back is the elastic strain energy (E_e).

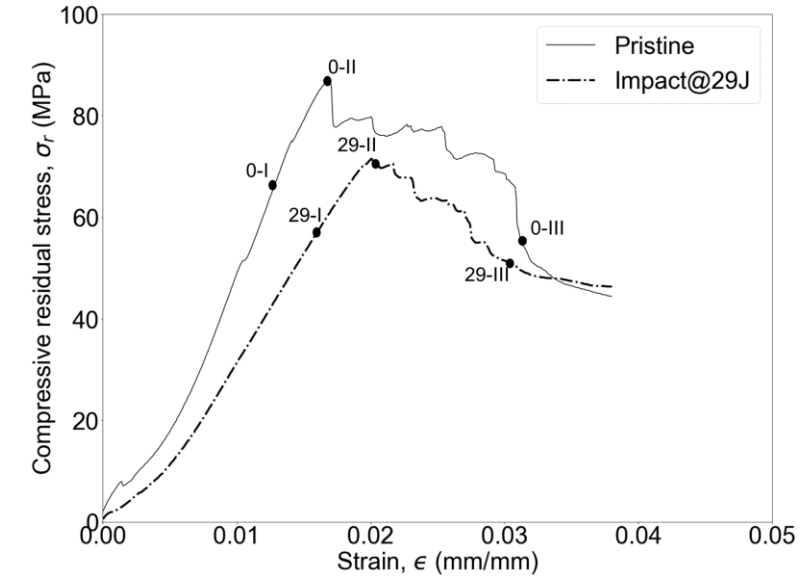
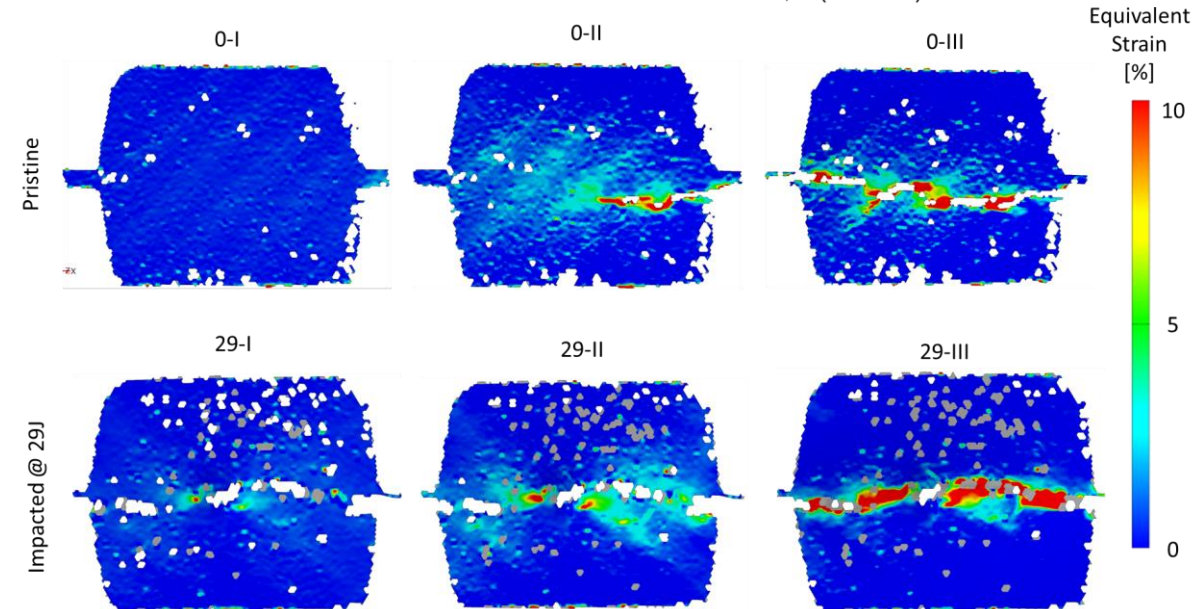
DIGITAL IMAGE CORRELATION (DIC) POST-MORTEM

- Pristine sample exhibited buckling during failure with no significant crack propagation visible on the surface.
- DIC strain field in the pristine sample showed strain evolving from one side and progressing through the middle.
- Impacted specimen showed damage development during compressive loading originating from the initial impact damage site.
- The impacted specimen also failed due to buckling, which is different from the brittle behavior typically observed in thermoset matrix composites.
