CARBON FIBER SUBFRAME DEVELOPEMNT – CORROSION MITIGATION STRATEGIES AND TEST RESULTS

Xiaoming Chen, Kyle Anderson, Niamh Hosking and David A. Wagner
Ford Motor Company
Nikhil Bolar
Magna, Cosma International

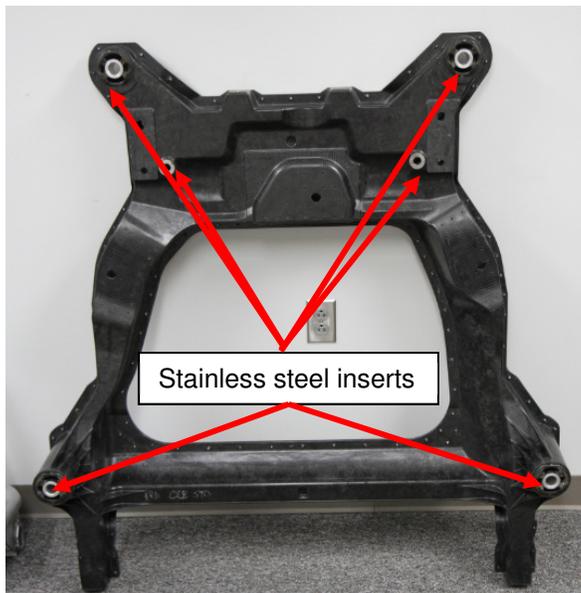
Figure 4: stainless steel insert in subframe

The CFRP composite subframe has six steel inserts. They are load bearing elements at the four body mounts and the two steering gear joints of the subframe. The inserts are made of stainless steel and are co-molded with the CFRP material (Figure 4). The detail of the body mount insert is shown in Figure 5.

The stainless steel inserts showed good condition without material loss, confirming this material's compatibility with CFRP.

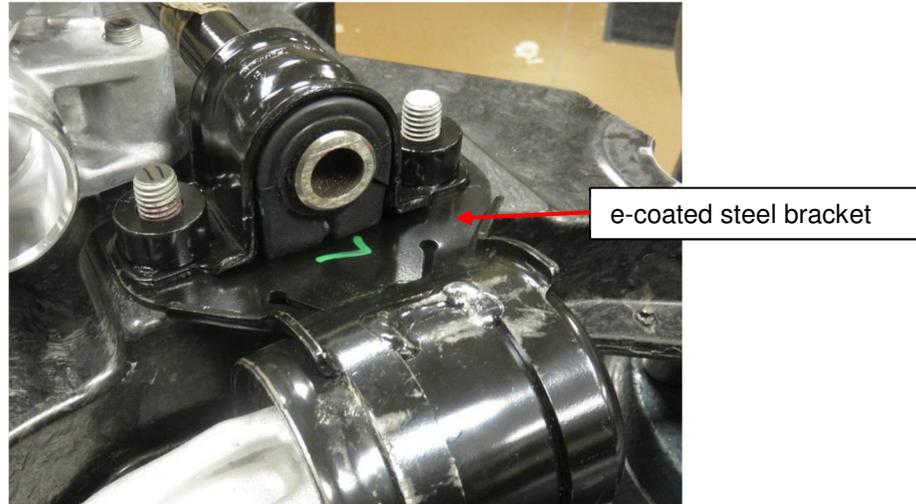
Figure 7: control arm rear joint with e-coated bracket

The control arm rear joints have steel brackets holding the bushings. The brackets are e-coated. It is a standard requirement for chassis brackets. There is no additional actions to separate the e-coated brackets and the CF composite surfaces at the control arm rear joints (Pt. 4). The Pt. 4 joint is shown in Figure 7.

The steel lower control arm brackets exhibited pitting on the surfaces in contact with the carbon fiber. The e-coat paint was not sufficient to avoid corrosion on the steel brackets for this design.

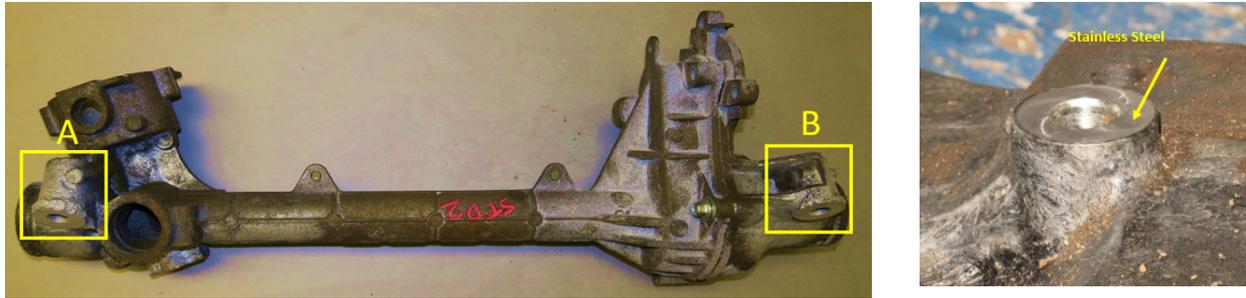
Figure 16: steering gear mounting surface

The aluminum steering gear was mounted to the CFRP subframe through stainless steel compression limiters (sleeves), as shown in Figure 16. The sleeves themselves did not exhibit corrosion; however, the mating surfaces on the steering gears experienced considerable metal loss at the interface (Figure 17). These observations confirm that stainless steel is compatible with CFRP but it may induce galvanic corrosion on an adjoining less noble metal, such as aluminum.

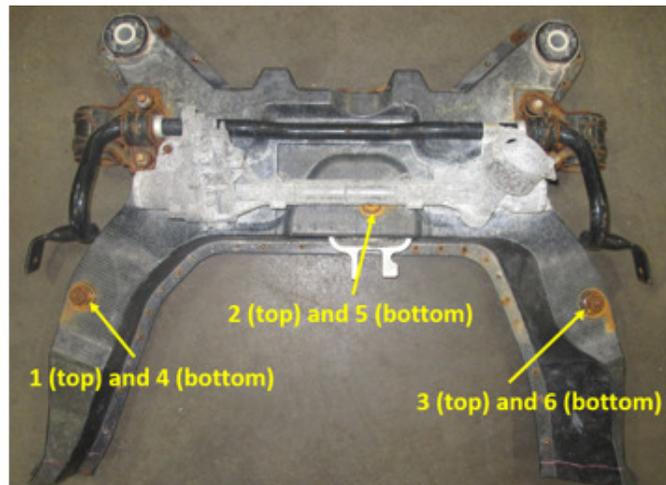
Figure 21: fasteners selected for rust study

Fasteners at the control arm front joints and the roll restrictor joint were studied in detail to check for any benefits of the glass veil and nylon coating strategies. The locations of the fasteners selected for the study are shown in Figure 21 and their appearance at the end of test is shown in greater detail in Figure 22.

Inspection of these fasteners indicated that the nylon 11 coating adhesion to the bolt/nut heads deteriorated, allowing the development of red rust, see for example B-1.1 and B-1.3. This deterioration could be due to damage of the coating during assembly and subsequent corrosion exposure. Washers with nylon coating did appear to have enhanced red rust resistance compared to bare washers, see for example B-1.5 compared to A-1.5 and B-2.5 compared to A-2.5.
